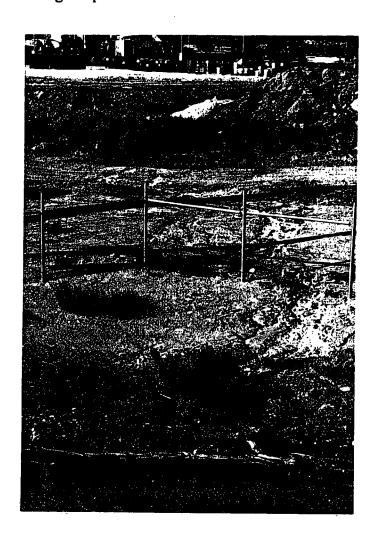
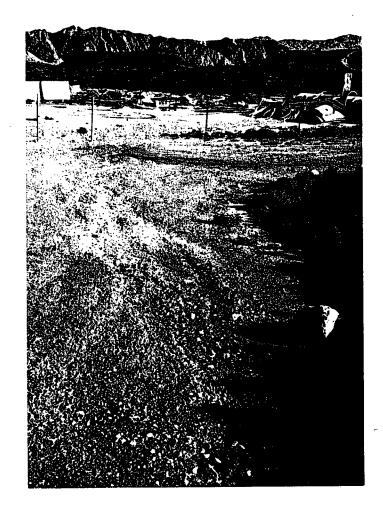
This is one of the areas of storm water runoff on the HECLA property, adjacent to the waste pile. The OMG tungsten plant feedstock storage area is in the background. The white deposit is waste from the cement trucks that dumped the water during the construction of the tungsten plant.

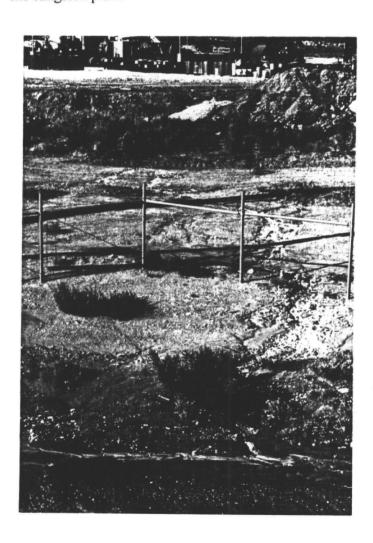
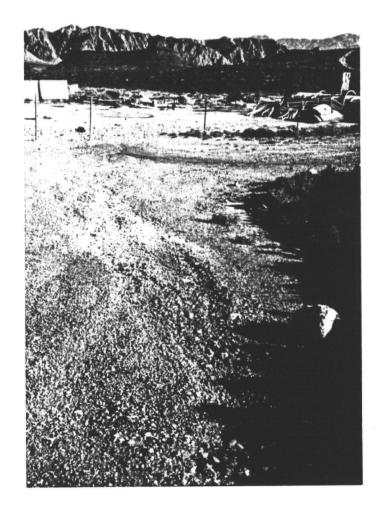
This is one of the areas of storm water runoff on the HECLA property, adjacent to the waste pile. The OMG tungsten plant feedstock storage area is in the background. The white deposit is waste from the cement trucks that dumped the water during the construction of the tungsten plant.

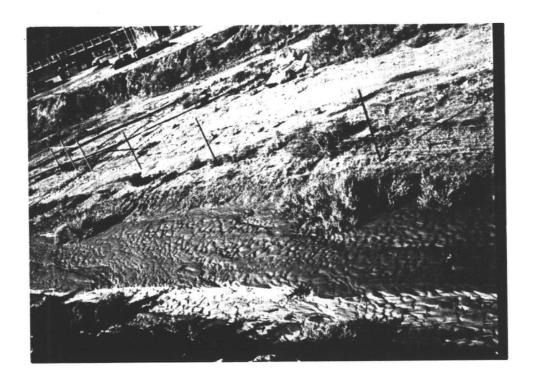
This is one of the areas of storm water runoff on the HECLA property, adjacent to the waste pile. OMG storm water also flows through here, then back onto OMG property.

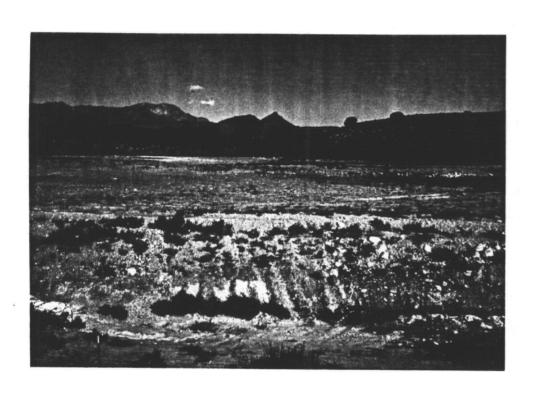
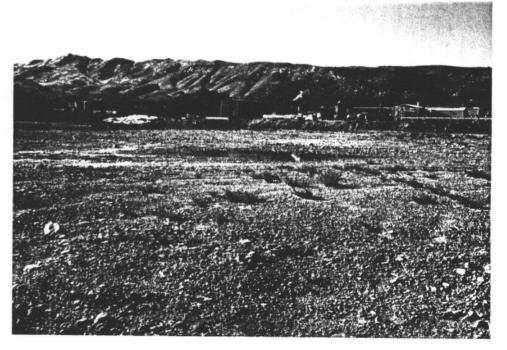
This is the top of the waste pile. There were two or three areas where the water ponds on top of the waste pile.

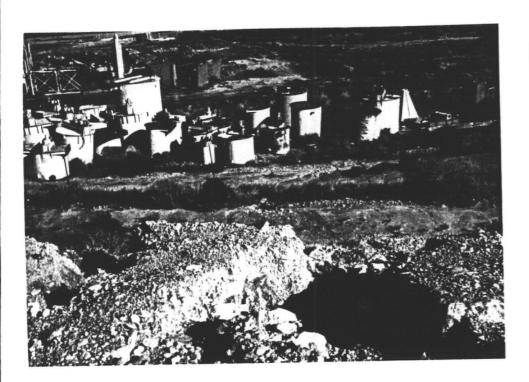
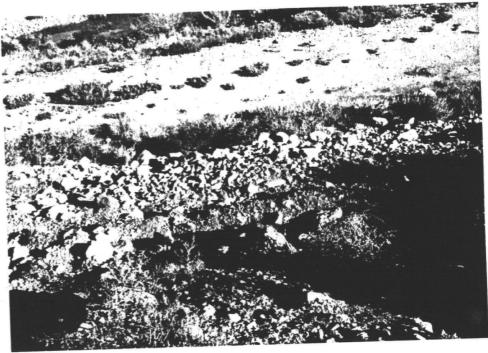
Areas of erosion around the perimeter of the waste pile.

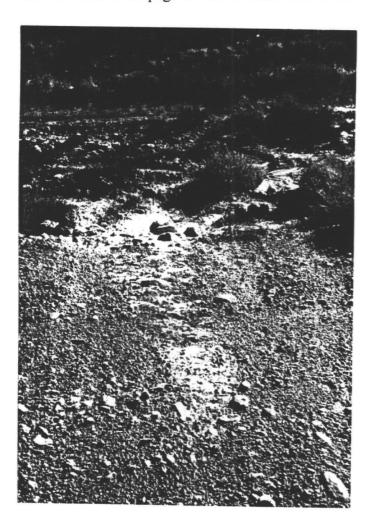
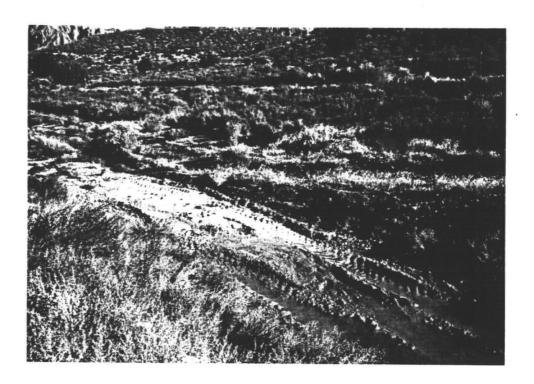
This is the area of seepage on the northeast side of the waste pile. The seep created crystalized deposits down gradient.

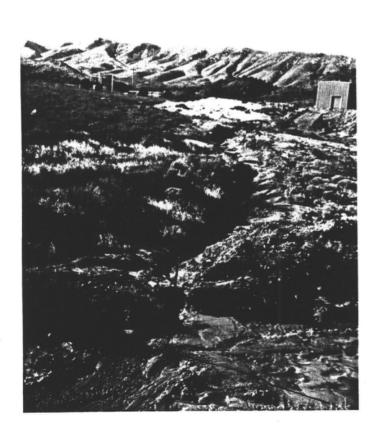
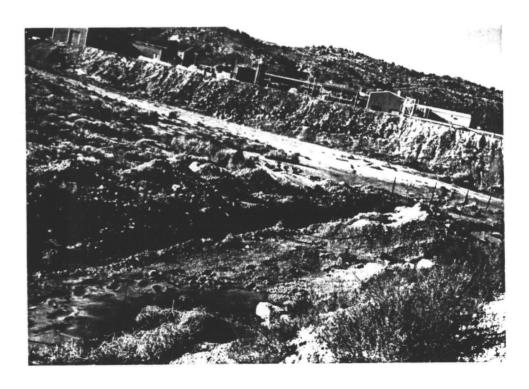
Ditches dug on OMG/Apex property to try and divert storm water flow away from HECLA property. The far right is the leachate collection pond for HECLA. The standing waters in the foreground from previous weekend of rain according to the facility. The photo was taken from the top of the waste pile.

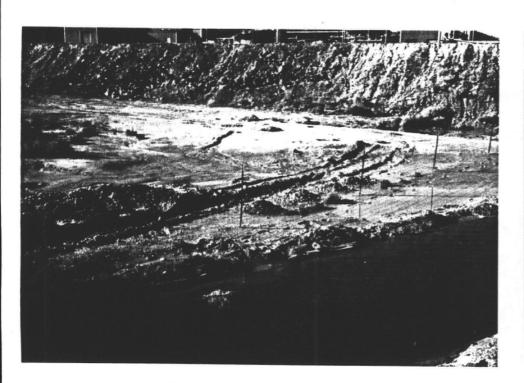
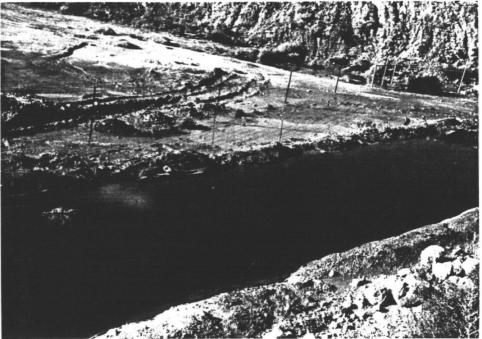
This is the lined leachate collection pond for HECLA. The photo was taken from the top of the waste pile. The pond was very full and may have overflowed recently. The embankment in the background is the berm of Pond 2 at OMG/Apex.

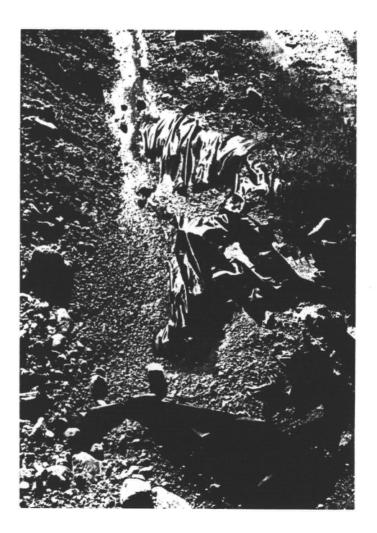
This is the beginning of the leachate collection trench, on the southwest side of the waste pile. The HDPE lined trench collects water from the waste pile and routes it to the collection pond for evaporation.

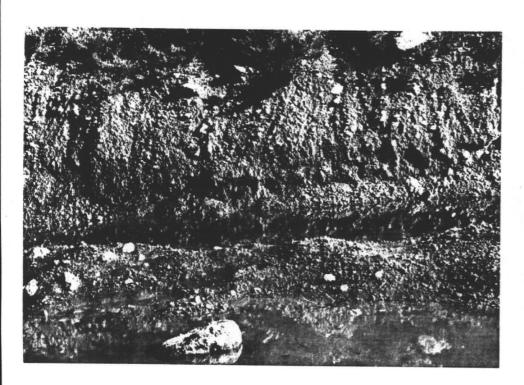
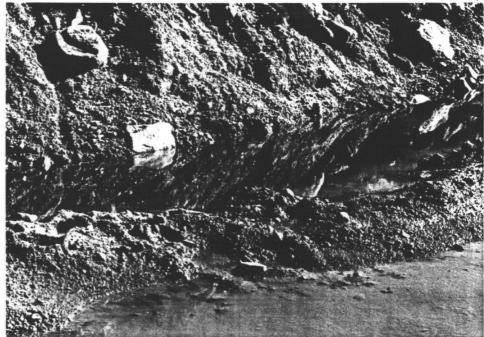
These are two of the areas along the leachate collection trench where it appears that there may have been a discharge. These are low areas in the berm and the ground was saturated.

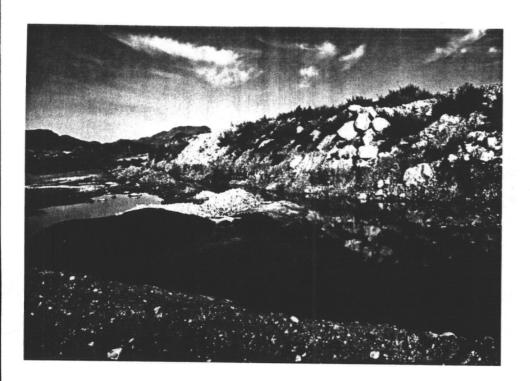
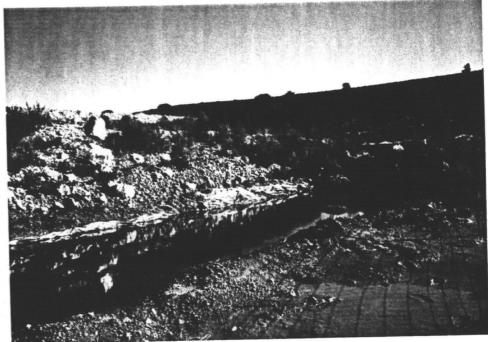
This is the leachate collection pond. The HDPE lined pond collects water from the trench for evaporation. The pond was full and there was standing water adjacent to the pond and the trench. There may have been a discharge from the pond. These are low areas in the berm and the ground was saturated.

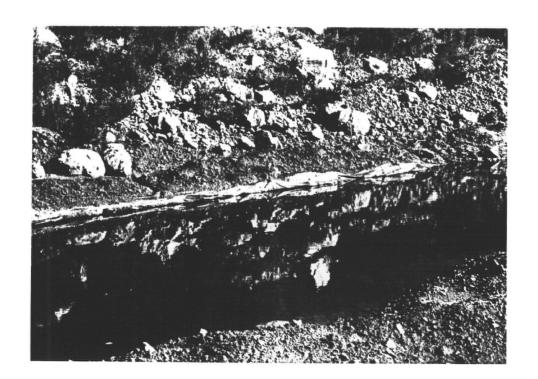
This is the leachate collection pond. The HDPE lined pond collects water from the trench for evaporation. The pond was full and there was standing water adjacent to the pond and the trench. There may have been a discharge from the pond.

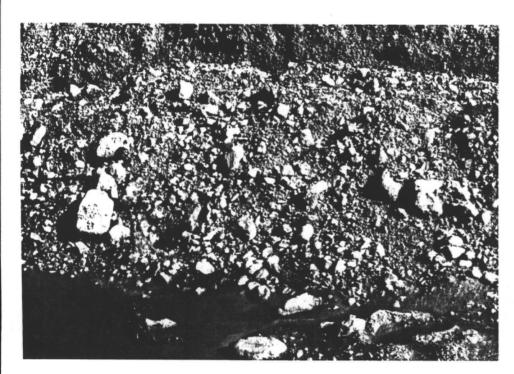
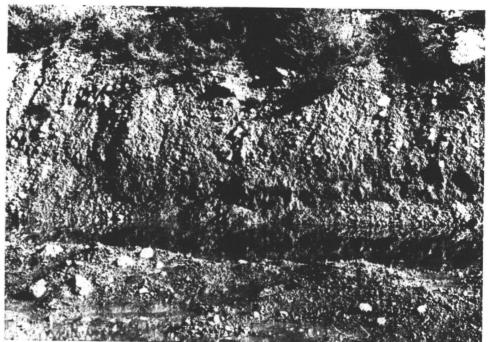
These are two of the areas along the leachate collection trench where water appears to be leaching out of the waste pile into the HDPE lined collection trench.

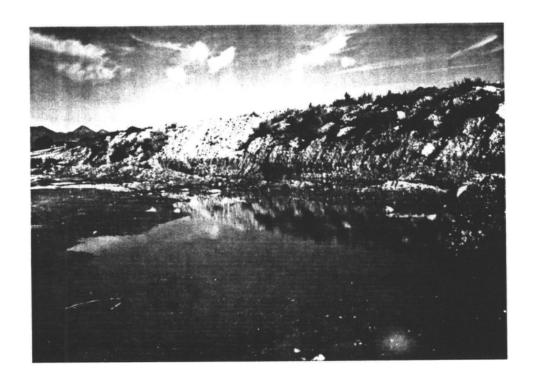
This is the area of standing waters adjacent to the collection trench and evaporation pond. The evaporation pond liner is seen on the far right and the collection trench is in the background.

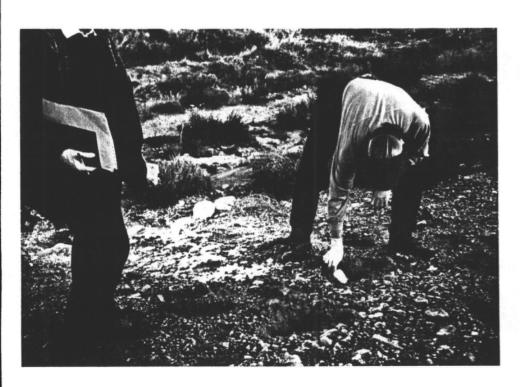
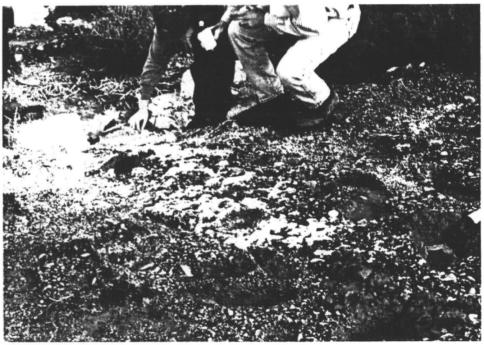
Samples collected from the area of seepage and crystallization on the northeast side of the waste pile. Small holes were dug and allowed to fill with water, water and sediment samples was collected, then the holes filled back in. Pieces of the crystalized material were collected for analysis.

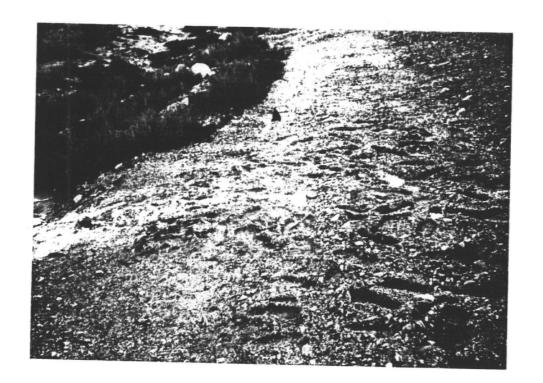
This is the area of seepage on the northeast side of the waste pile, after sampling was completed.

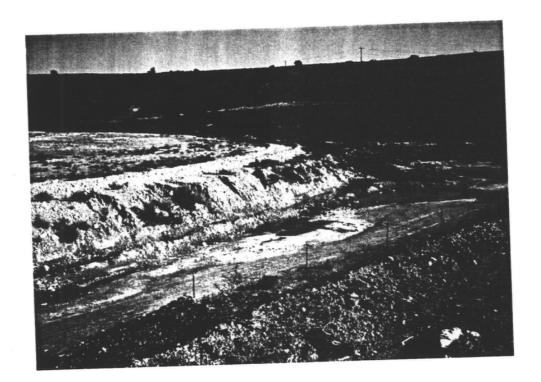
The photo was taken from the top of the berm on Pond 1 at OMG. This is an overview of the collection trench and evaporation pond. There is still water adjacent to the trench and pond.
